Appendix A-1 – New York

Damaged, unsecured, and broken poles

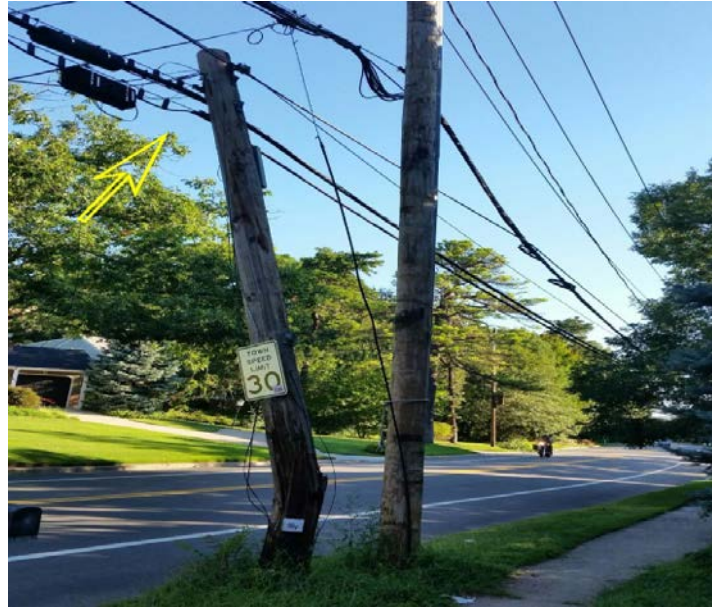
1. This picture below from Suffolk County, NY shows a public safety issue. The power company and the cable company have transferred their facilities to the new pole, but Verizon has not. The only thing holding up the old pole with the Verizon equipment on it is tension. If the tension breaks, the pole will fall.

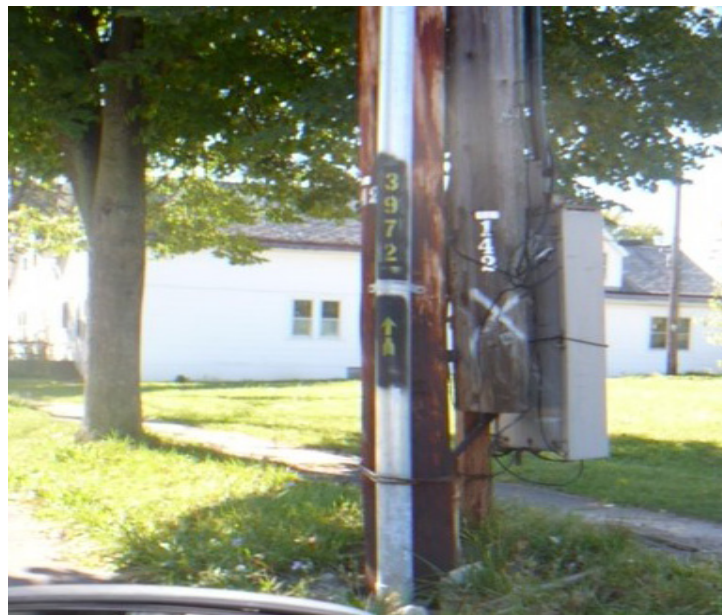
2. This picture below from Buffalo, NY shows a double pole. The old pole has the cross box on it, and is severed at the bottom. The cross box is a very heavy weight on the pole. The cross box is tied to the post behind it. It should be properly attached to the new pole.

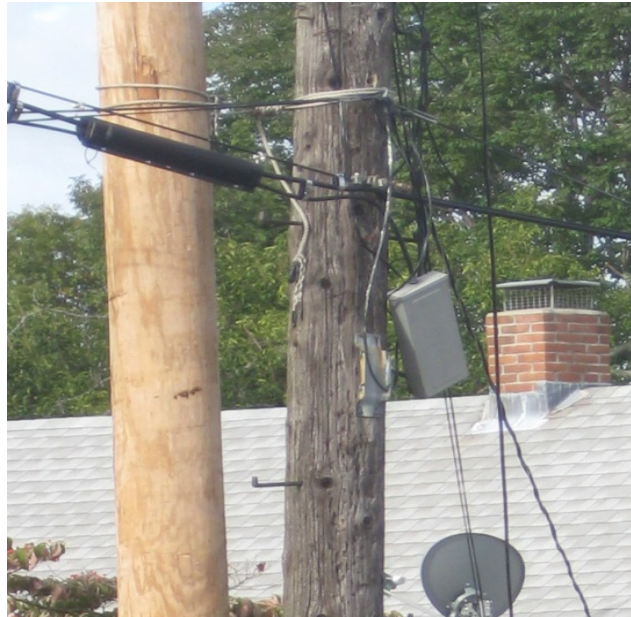
3. This picture below from Beacon, NY shows a double pole and a falling terminal. This is an example of a double pole which can be found throughout NY State. The power company installed a new pole and moved their equipment but Verizon did not transfer its equipment. The old pole is tied to the new pole. There is also an unattached terminal which can swing in the wind and break, causing a service outage.

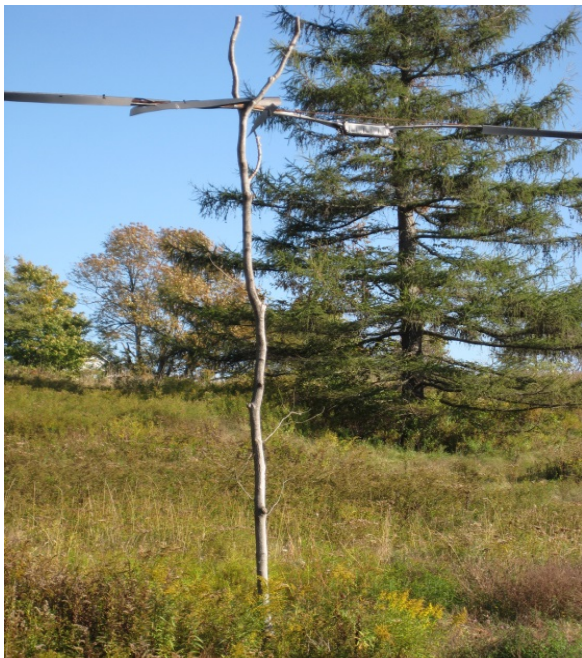
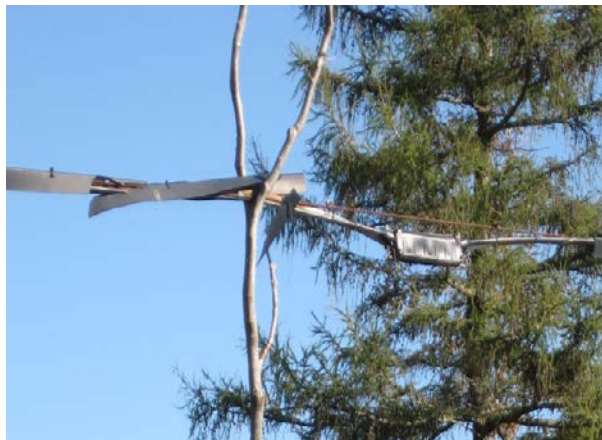
4. These pictures below from Fallsburg, NY show a tree holding up a cable.

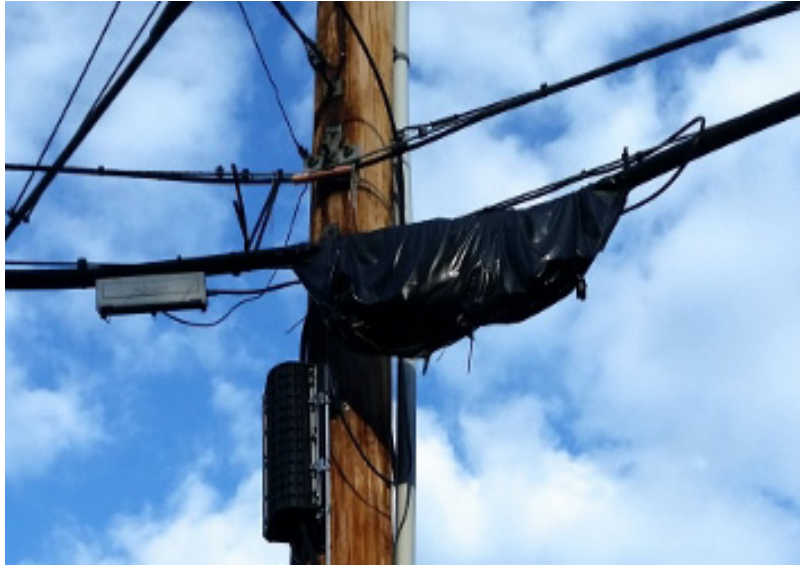
5. This picture below from Llyod, NY shows a plastic tarp covering exposed wires. This leaves the wires exposed to rain and animal infestation. This should have a permanent splice case. The cable is not attached to the strand but is tied to the fiber optic cable above it.

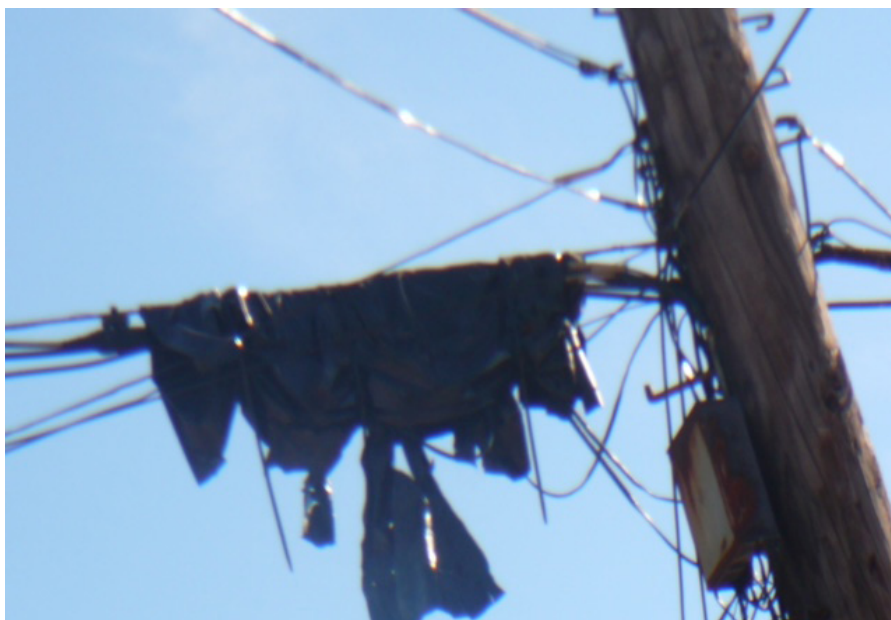
6. This picture below from Buffalo, NY shows several problems. First, there is a deteriorated, shredded tarp covering exposed wires. Second, the cable and the wires on the right-hand side of the tarp are exposed to the weather. Third, the wires should be connected to the terminal (the box on the pole) but they are not. Fourth, the service terminal is rusted out and likely cannot be opened.

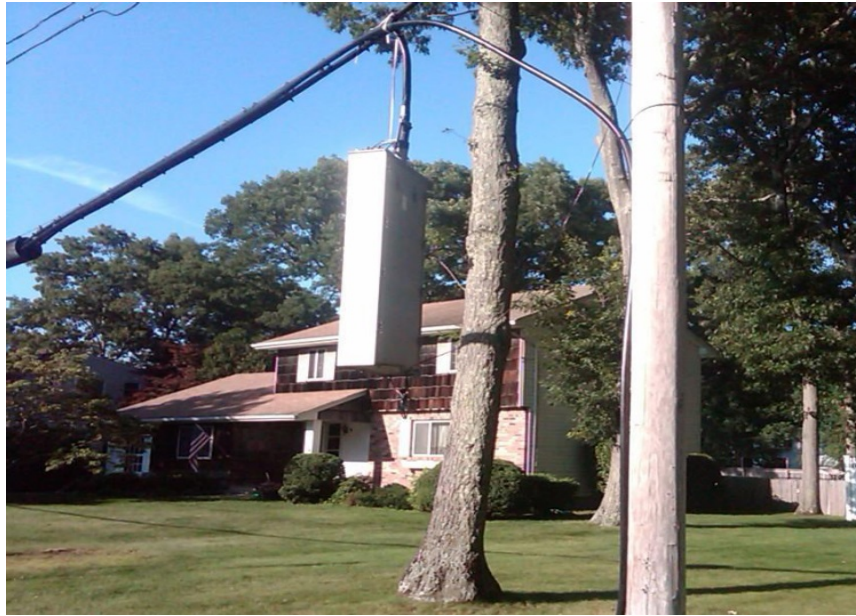
7. This picture below from Suffolk County, NY shows unattached facilities. This is a 3600 pair heavy cross box that is not attached to the pole. The pole is too far away. The cross box needs to be replaced and attached to the pole. This is a public safety hazard.

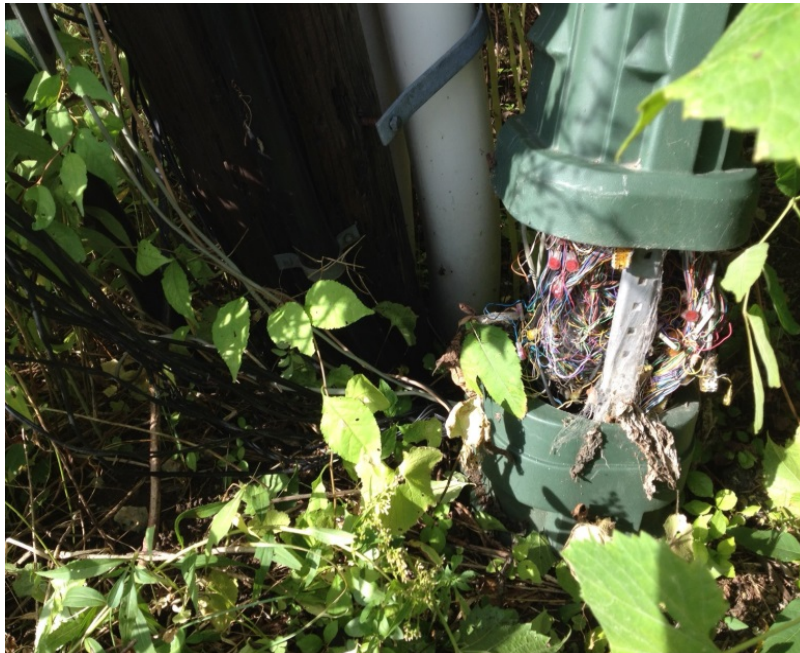
8. This picture from Wingdale, NY shows pedestal with buried cable. It is exposed to the elements. There are cobwebs and leaves indicating this has been exposed for a very long time, allowing water and animals in. Each little red button at the end of a wire indicates where a wire has broken or eaten by mice.

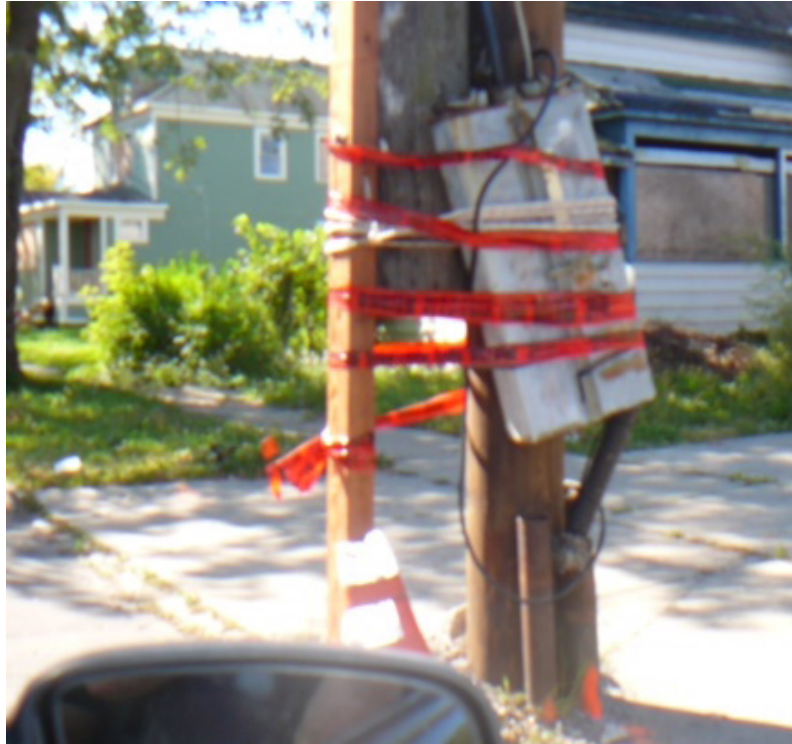
9. This picture below from Buffalo, NY shows unattached facilities. This is a cross-box strapped to a pole and a post (on the left) with caution tape and a rope. There is no way to get into the cross box for repair. The cross box is not attached properly and is a public safety issue.

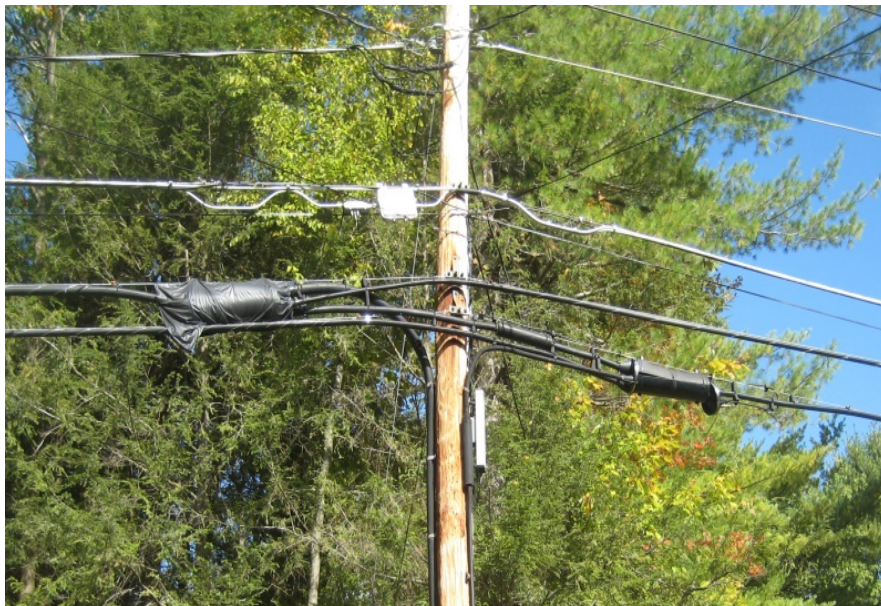
10. This picture below from Fallsburg, NY shows damaged facilities. On the right-hand side of the pole, there is a splice case that is not closed, exposing the cable to weather and animals.

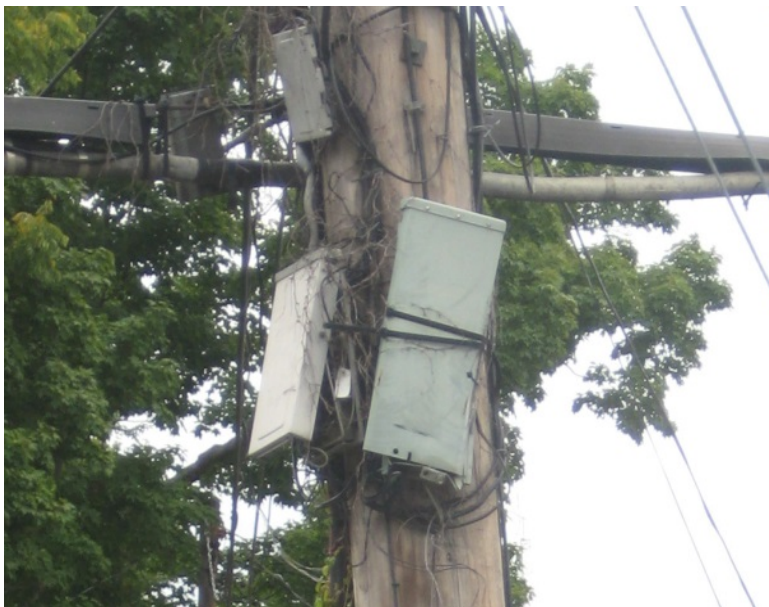
11. This picture below from Beacon, NY shows lead cable that is over 70 years old (the grey cable). Verizon was supposed to get rid of lead cable over 30 years ago. The black “squirrel guard” that is above the lead cable should enclose it, but it doesn’t. This allows squirrels to eat the lead cable (which they love), gnaw holes in it, and allow water to enter the paper cable inside, causing outages. This picture also shows 3 terminals stuffed with service wires. The silver terminal is open. The green terminal is strapped to the pole.

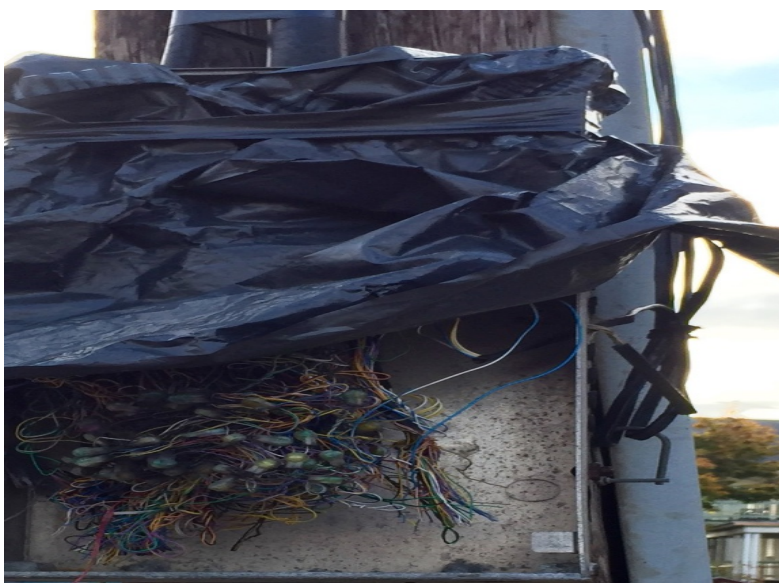
12. This picture below from Utica, NY shows exposed wires at an access point. The access point box is missing its door. There are a lot of corroded wires (green color indicates corrosion). It is only partially covered by a tarp. Exposure to rain, snow, and weather breaks down the wires and leads to service outages.

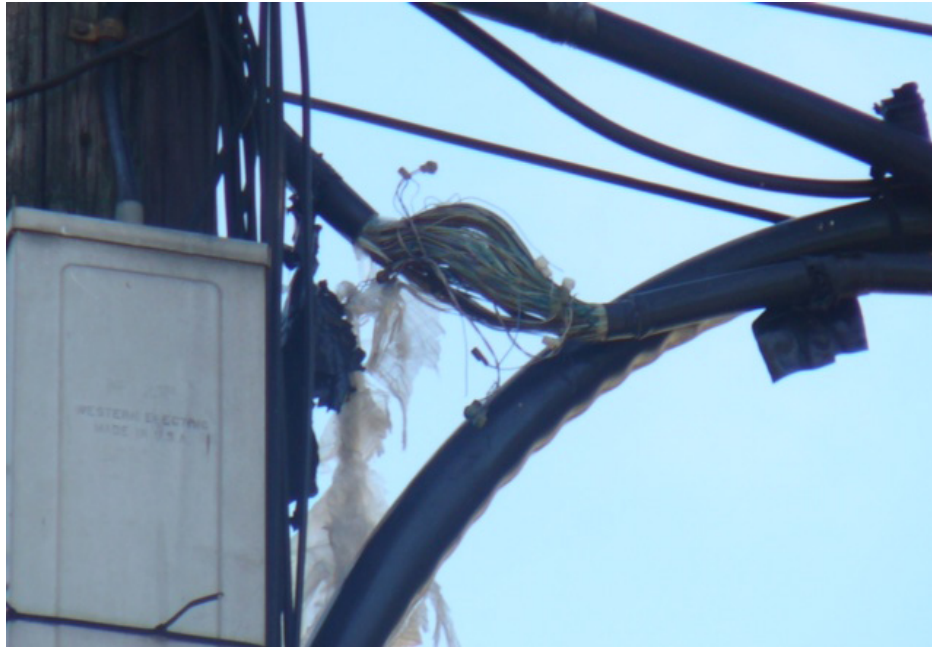
13. This picture below from Buffalo, NY shows exposed facilities. The sheath on the cable is gone, which exposes the wires to the weather and animals. This will lead to corrosion and service outages.

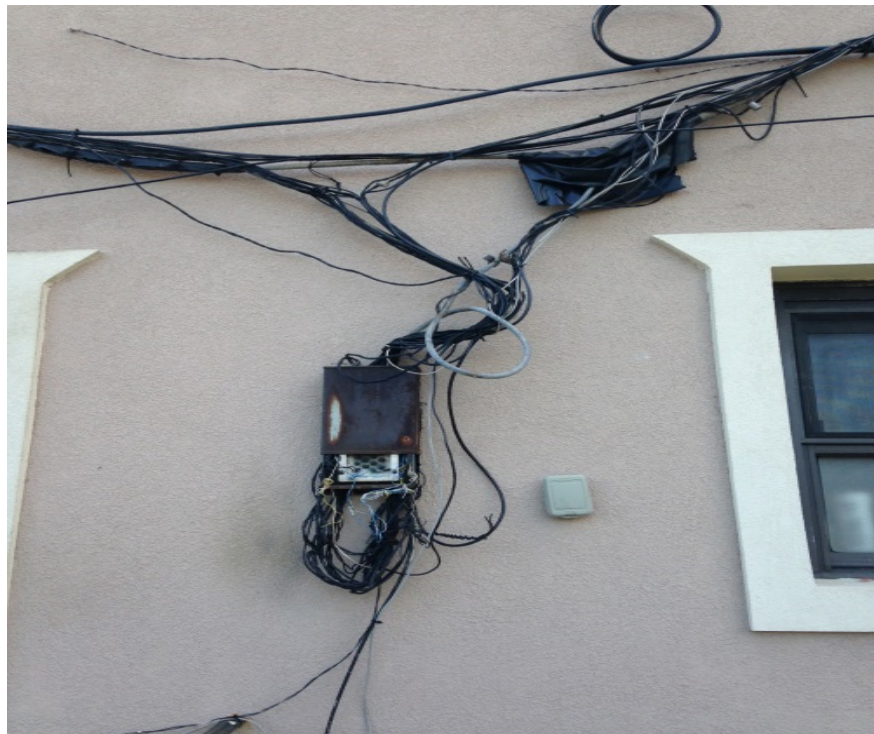
14. This picture below from Queens, NY shows exposed facilities. This is a very old copper terminal. It is open and can't be closed because there are too many wires going into it. This terminal should have been replaced. The wires are not attached to the building.

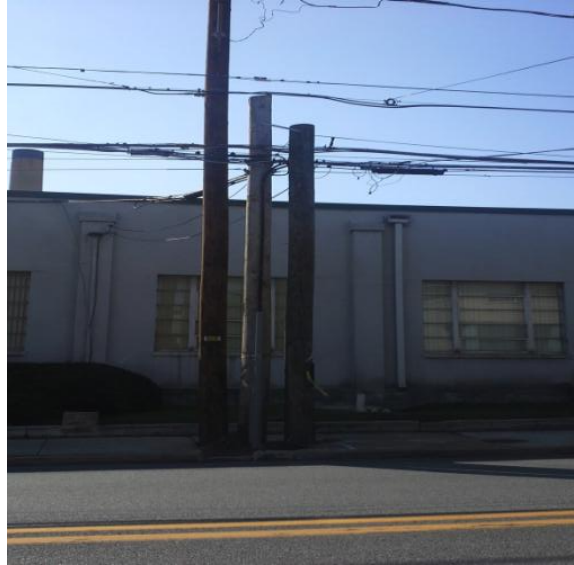
1. This picture below shows a triple pole. This represents two generations of poles that Verizon PA has allowed to remain in place without regard to the safety of line workers and the public.

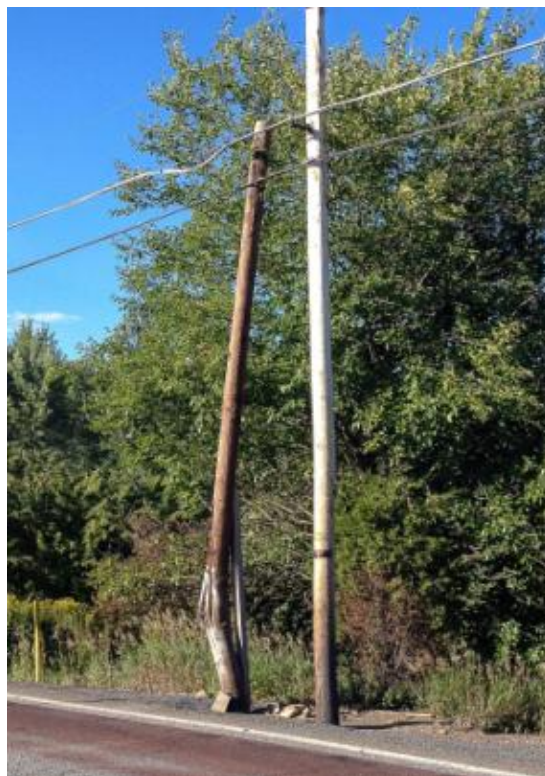
2. This picture below shows a double pole. The old pole has splintered and is being supported by the cables. The old pole puts pressure on the cables. This could lead to falling cables, service outages and public safety issues.

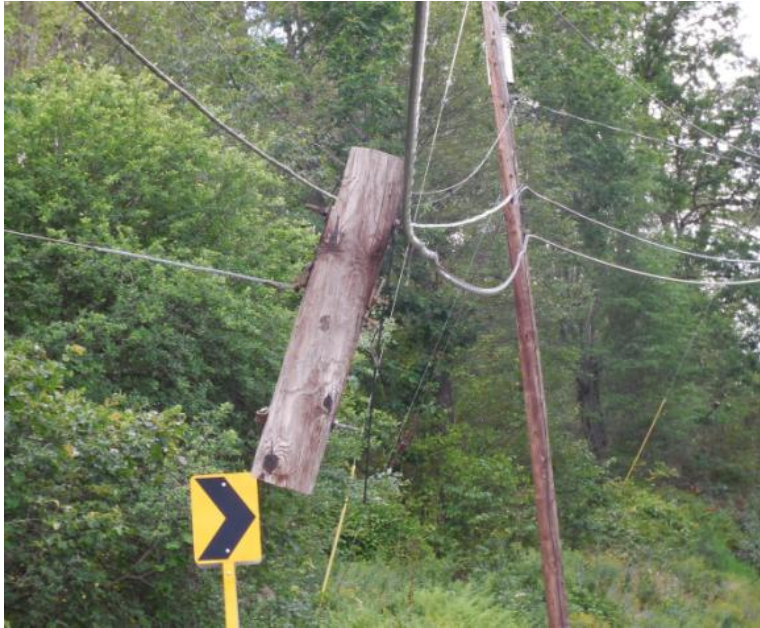
3. This picture below shows a hanging double pole. When VZPA doesn't replace its poles, and the electric utility must remove the pole from the base, the utility may leave the portion of the old pole containing VZPA facilities just dangling over the right-of-way, tied to the new pole by a single cable or, as shown below, propped up with a make-shift support.

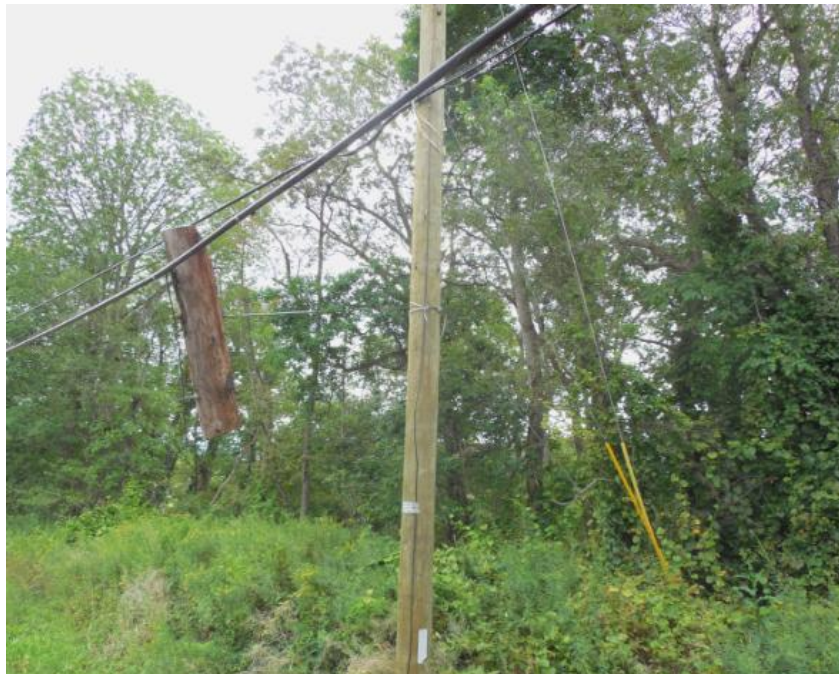
4. This picture below shows a hanging pole. Leaving a portion of the old pole hanging is not only dangerous to the public, but also poses a serious hazard to utility workers who must navigate this heavy foreign object and try to find a safe and secure way to work on the facilities attached to the old bit of pole.

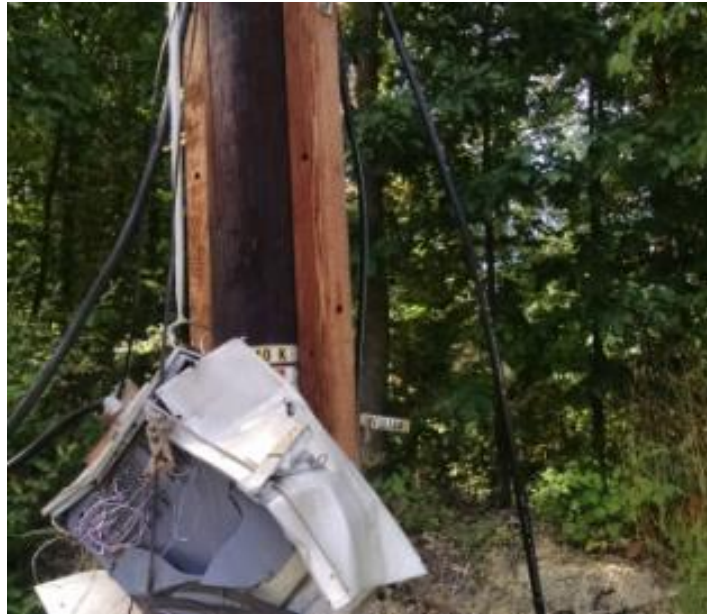
5. This picture below shows a damaged cross-connect cabinet. Large cables, containing hundreds of pairs of the individual conductors that serve customers, enter the cabinet and are then split into their individual circuits. Damaged cross-connect boxes have a direct impact on the reliability of service to customers as wires get damaged, rained on, chewed by animals, or disconnected.

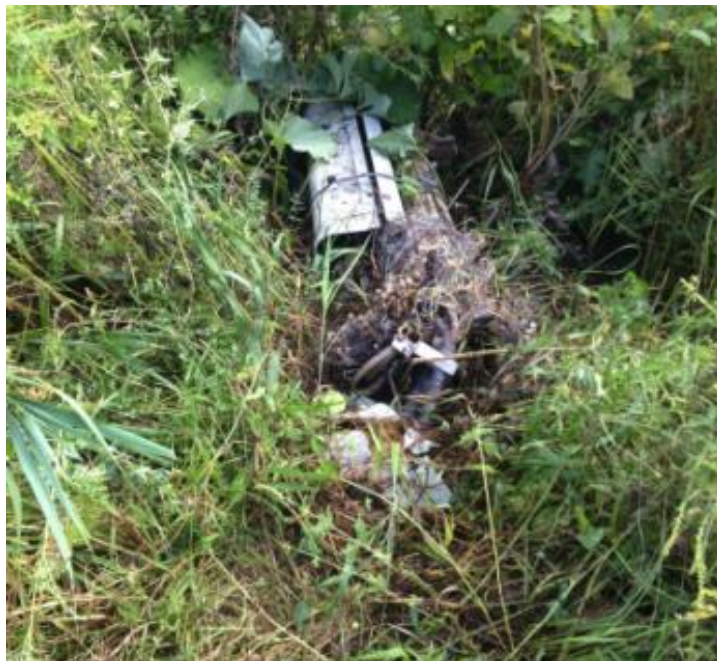
6. This picture below shows a badly damaged terminal. It is exposed to the elements and animals. This leads to service issues and poses a public safety issue.

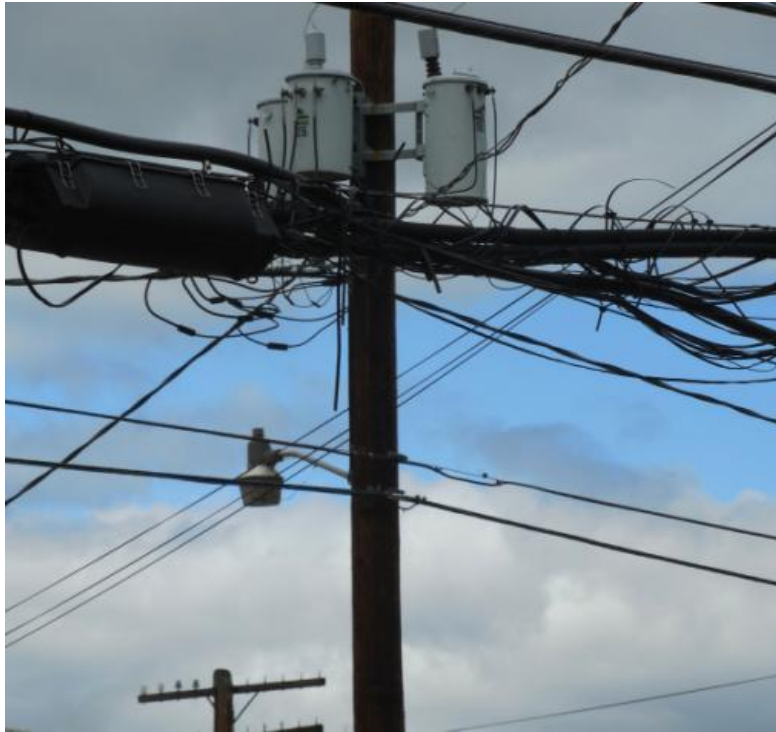
7. This picture below shows a defective cable that should be replaced. Each small wire represents a response to a different customer's service complaint, and likely represents a separate service call and trip up the pole for a field worker.

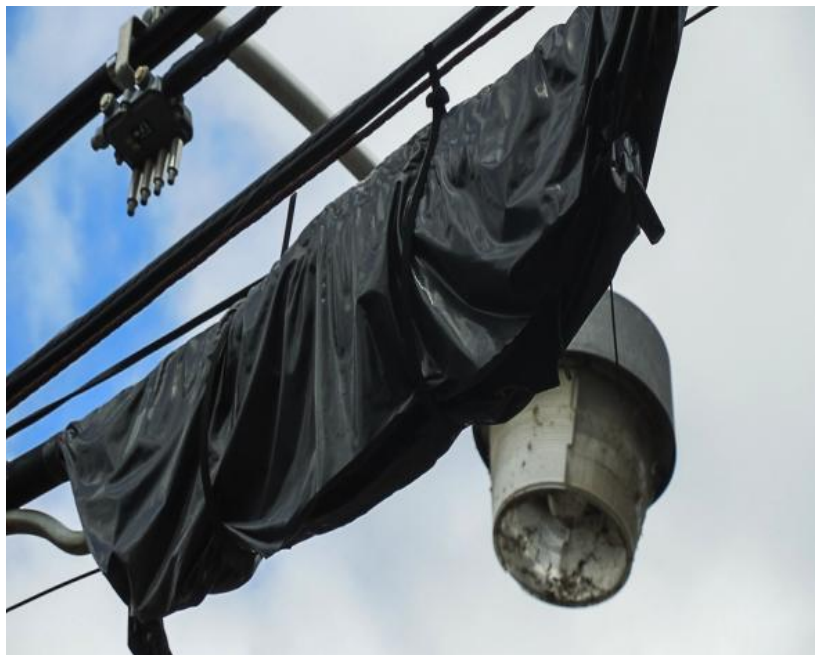
8. This picture below shows a plastic tarp covering exposed wires. This leaves the wires exposed to rain and animal infestation. This should have a permanent splice case. The cable is not attached to the strand but is tied to the cable above it.

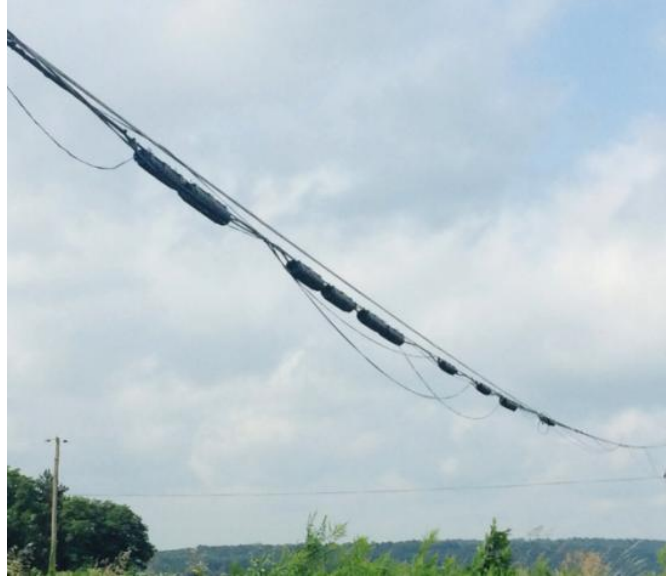
9. This picture below shows a single cable that has become so damaged there are at least 10 splice boxes on a single span of a few hundred feet. Each splice box covers a portion of damaged or defective cable. Each of the numerous thin wires would have been installed in response to a separate customer complaint.

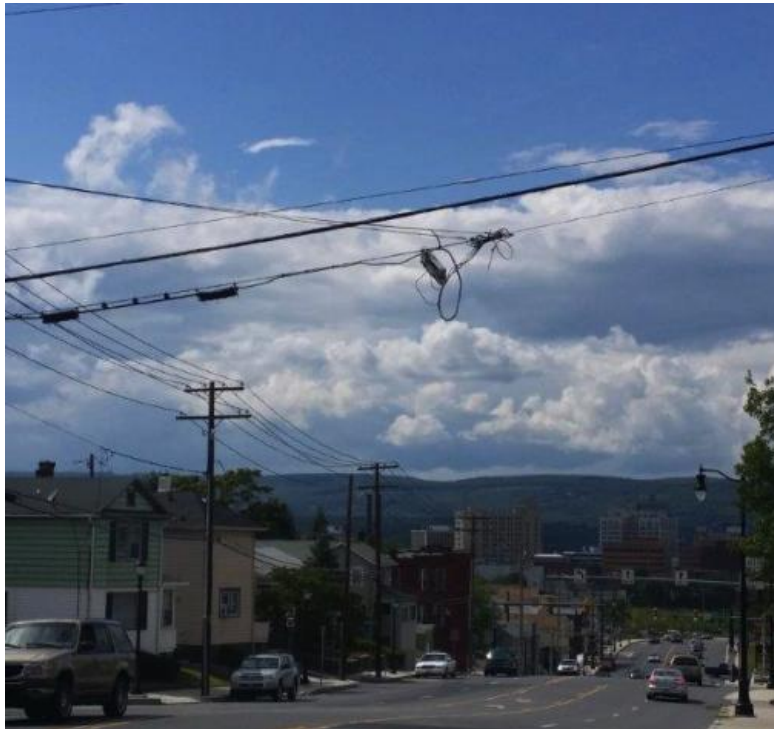
10. This picture below shows a damaged terminal hanging unconnected above a busy highway. The terminal is putting pressure on the cable and could fall or pull down the cable into the street, leading to service issues and serious safety issues.

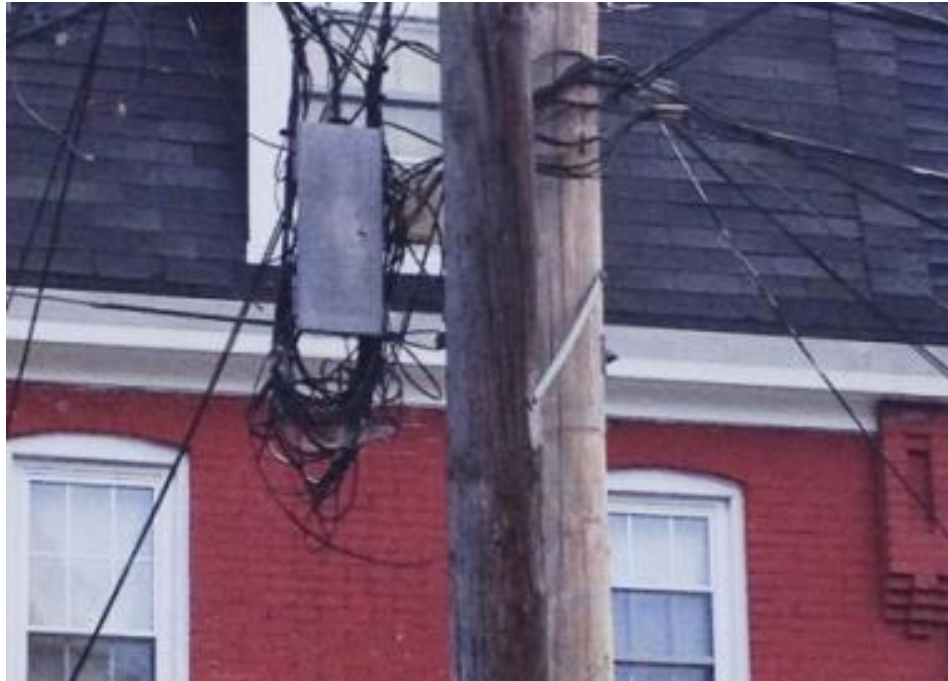
11. This picture below shows a terminal box pulled off the pole. This is both a worker safety and service affecting concern because the wire will deteriorate and the terminal will swing loose on the pole or open and expose the wires.

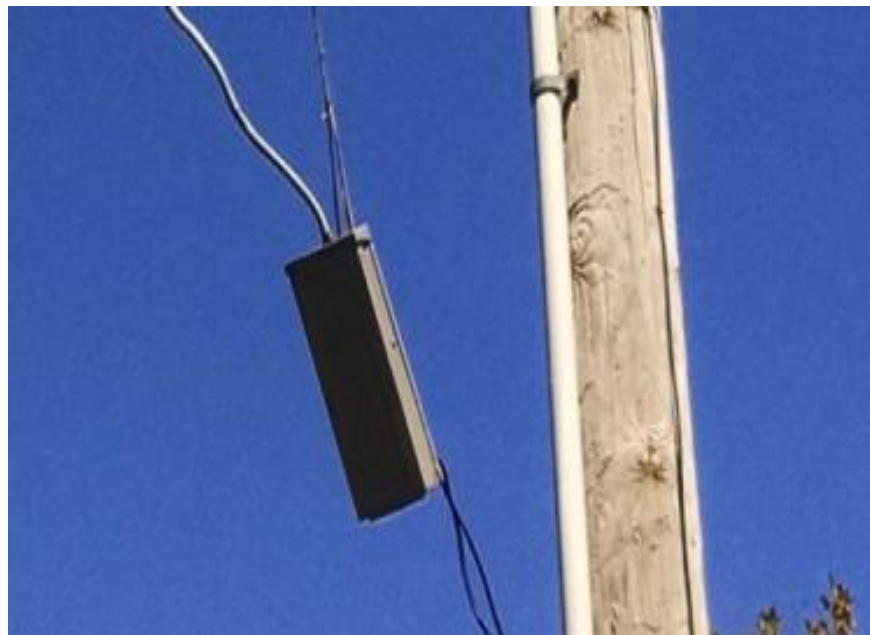
12. This picture below shows an unsecured terminal hanging from service wires. The terminal should be secured to the pole. The terminal can fill with water, deteriorating wires and leading to service issues. In addition, a hanging terminal presents a public safety hazard.

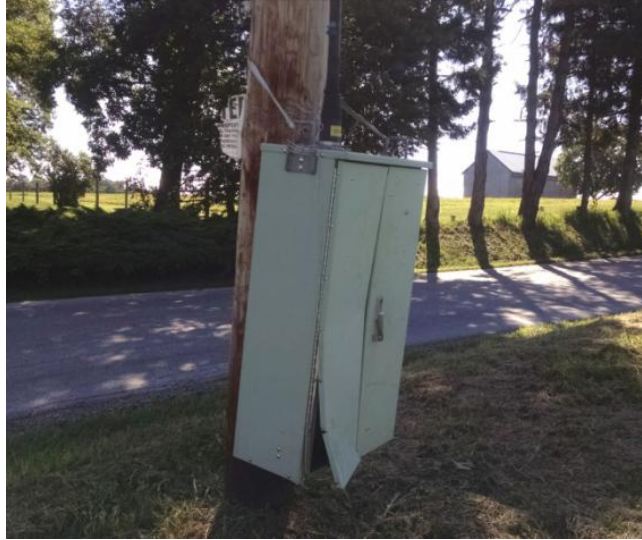
13. This picture shows a damaged terminal. The box's protective case is damaged, leaving the internal wires exposed to weather and animals. Damaged wires cause service outages. In addition, the exposed wires are a public safety hazard.

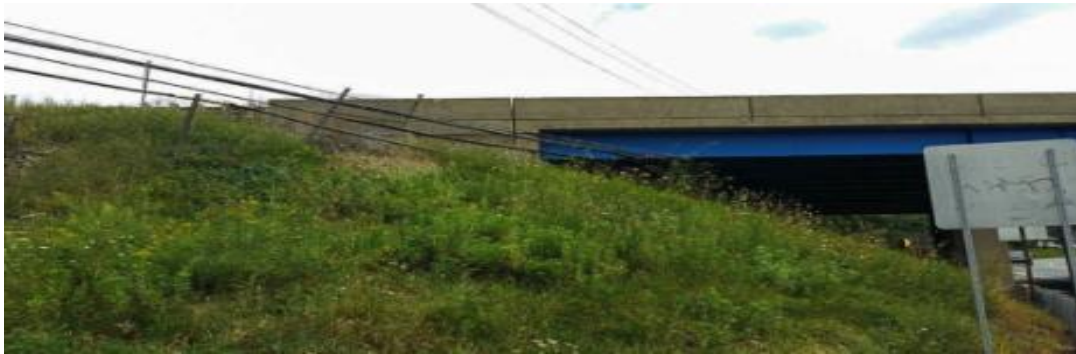
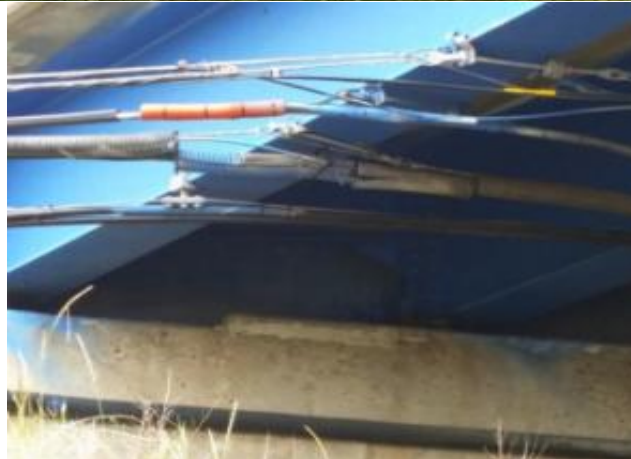
14. These pictures below show cables attached to a fence, so the cables run underneath a bridge instead of over the top (as the electricity cables do), and are left damaged and exposed.

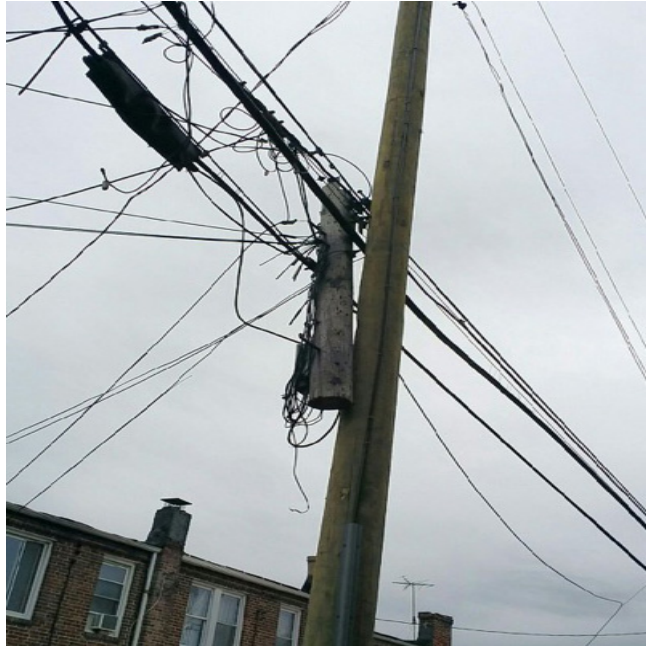
1. The picture below from rear of 2405 West Cold Spring Lane, Baltimore City, MD shows a “double-wood.” An old utility pole has been cut with Verizon’s terminal still attached to it. The old pole does not appear secured to the new pole. It is left dangling causing a hazard to the public. It is a worker and public safety concern.

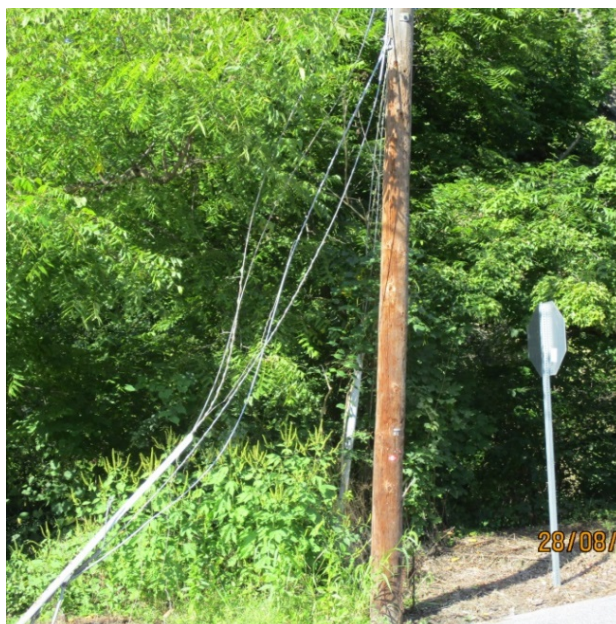
2. The picture below from 1521 Hunter Mill Road, Parkton in Baltimore County, MD shows a utility pole with no tension in the guy wires. Without the tension in the guy wires, there is a higher risk of the pole falling over. This is a public safety concern.

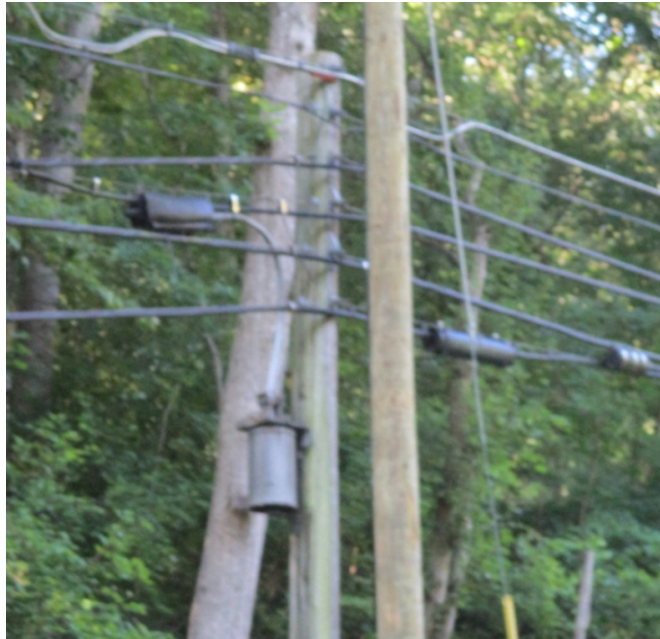
3. The picture below from Frt.1214 Wiseburg Road, Parkton in Baltimore County, MD shows a “triple-wood,” where the utility company has replaced a pole but Verizon has not yet transferred over its six cables.

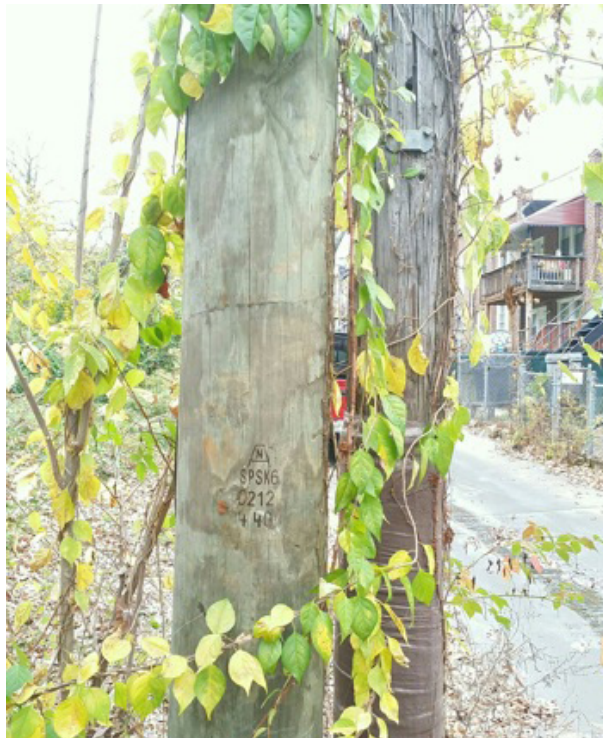
4. The picture below from rear of 2455 West Cold Spring Lane in Baltimore City, MD shows a “double-wood.” The newer pole was installed in February 2012. The base of the old pole is wrapped in fiberglass to serve as a “pole cast,” and there is a rod driven into it to hold it up.

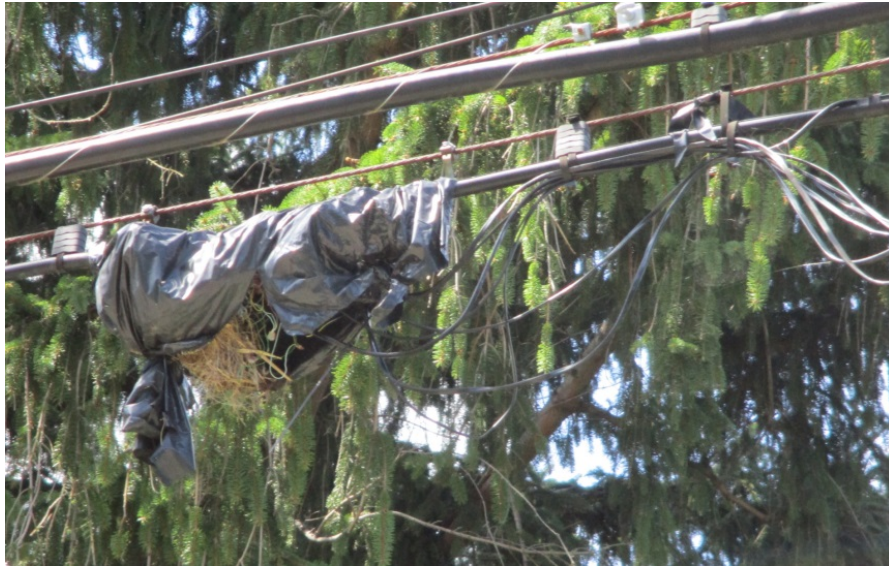
5. The picture below from Manor, Baltimore County, MD shows a deteriorated cable covered by deteriorated black plastic wrap. Wires are exposed to the elements and an animal has nested inside the wrap. Weather and wildlife affect service. On the right side of the picture, “drop wires” are bypassing the defective cable. Drop wires are not meant for outdoor use, deteriorate more quickly than cable, and their use will affect service.

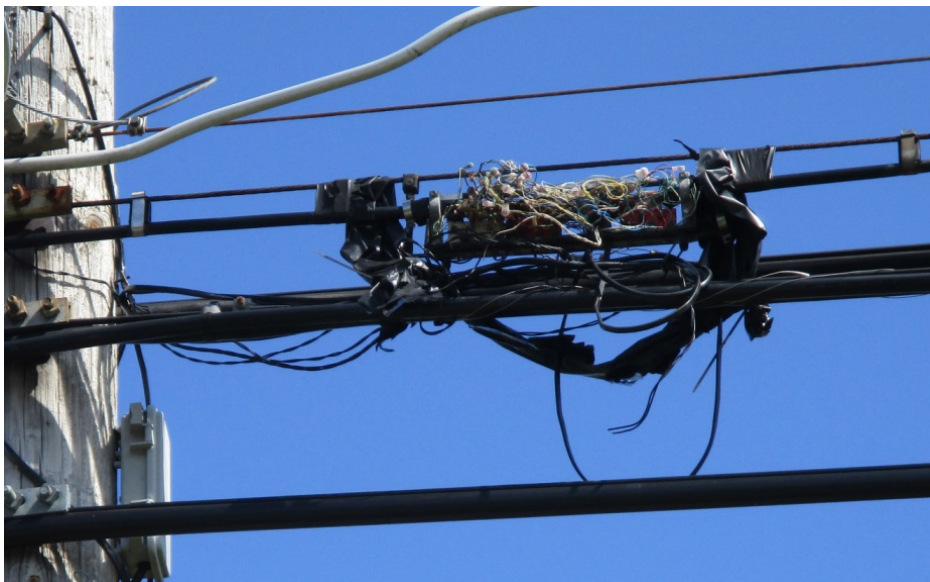
6. The picture below from Frt. 1525 Walker Avenue, Parkton in Baltimore County, MD shows the remnants of a deteriorated black plastic wrap and exposed wires. There is no hard case to protect the exposed wires and the temporary plastic wrap did not last. Exposed wires are susceptible to damage from weather and animals. Damaged wires cause service outages. The discolored wires indicate long exposure to weather.

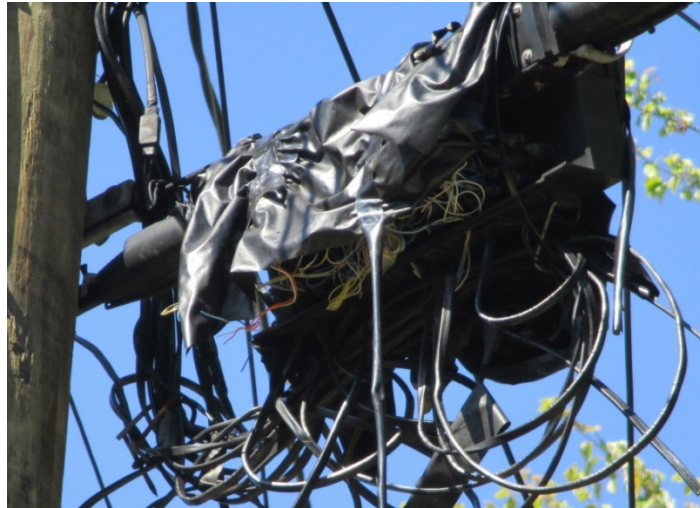
7. The picture below from rear 3506 Northway Drive, Baltimore, in Baltimore County, MD shows a deteriorated plastic covering. The exposed wires underneath the plastic are discolored indicating the condition of this splice has existed for some time like this. These wires are susceptible to damage from weather and animals and allows for animal infestation. Damaged wires affect service.

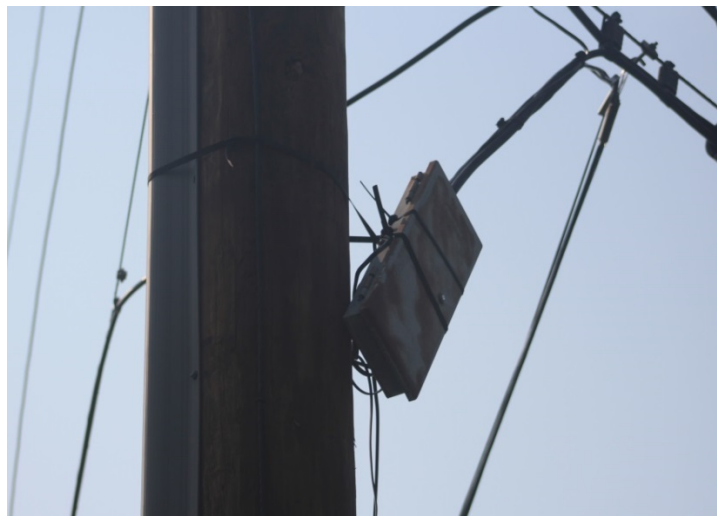
8. The picture below from Pole 22 on Thompson Creek Road, Stevensville in Queen Anne's County, MD shows a terminal box pulled off the pole, wrapped shut and tied to the pole with wire. The cable feeding the terminal is not long enough to fasten the serving terminal to the pole vertically. Working on the terminal presents a safety challenge for the technician because it would require untying the wire, which would then cause the terminal's sharp-edged front lid to fall on the technician. This is both a worker safety and service affecting concern because the wire will deteriorate and the terminal will swing loose on the pole or open and expose the wires.

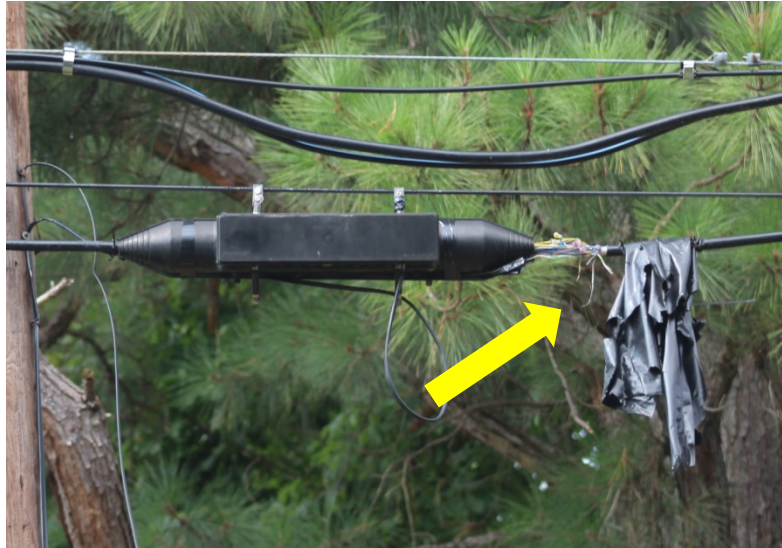
9. The picture below from Pole 4 on North Lake Drive, Stevensville in Queen Anne’s County, MD shows deteriorated plastic wrapping that has uncovered the side of the splice closure it was intended to protect. The cable has been pulled out of the terminal exposing the wires to the elements, which causes deteriorating wires and service outages.

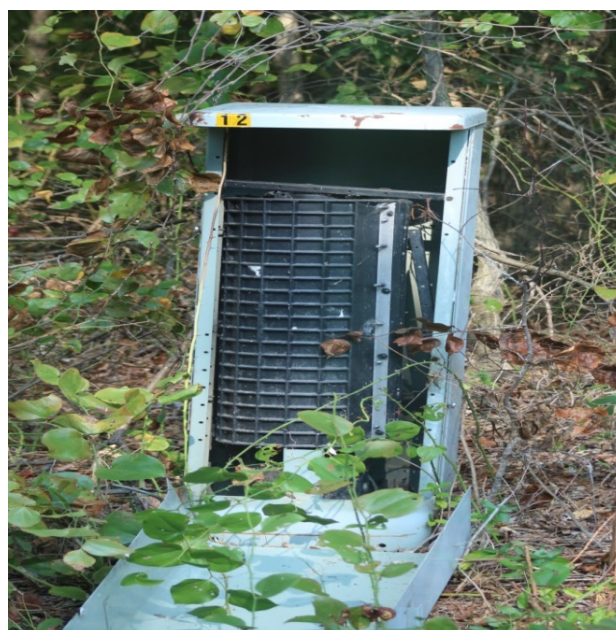
10. The picture below shows Pedestal 12 on Romancoke Road, Stevensville in Queen Anne’s County, MD with a lid cover that will not close. Without a cover, the pedestal’s internal wiring is exposed to animals and weather, both of which can affect service. A technician has attempted to protect the internal wiring that provides customers’ service by placing a “waffle case” over the wiring. Waffle cases are used in a manhole or on aerial cables, not pedestals. The overgrowth on the lid and pedestal suggests the condition of this pedestal has existed and gone without needed repair for some time. This is a public safety hazard.

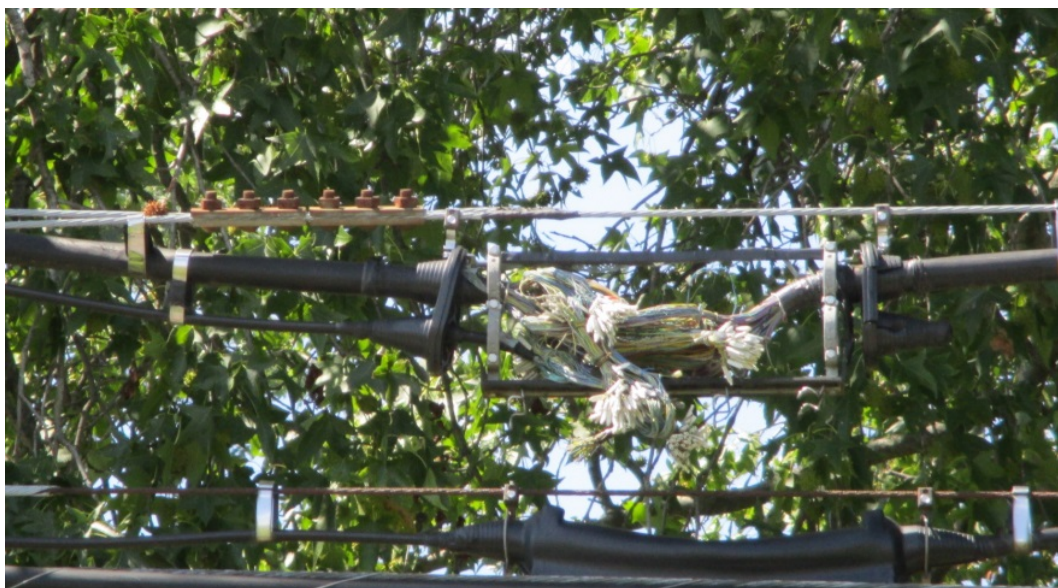
11. The picture below from 13108 Manor Road, Manor in Baltimore County, MD shows a missing splicer terminal case. The wires are exposed to animals and the elements, causing service outages. Discolored wires indicated long exposure to weather.
